WEAR INDUCED HARDENING OF LASER PROCESSED CHROMIUM-CARBON STEEL

Published in:
Scripta Metallurgica

H. De Beurs and J. Th. M. De Hosson

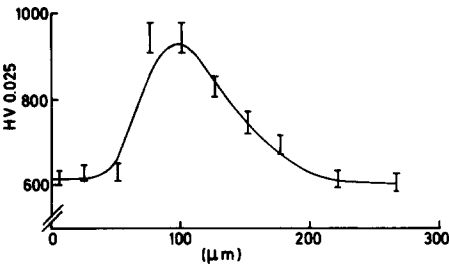
Fig. 3a Hardness profile of a wear track on laser melted chromium steel after 10 000 turns.

Hardness measurements on wear tracks of laser melted chromium steel reveal a wear induced hardening. The hardness is measured across the weartracks with a Vickers hardness tester. A load of 25 grf. is used. In fig. 3a the hardness profile is given after 10000 turns. Fig. 3b shows the wear induced hardnesses of laser treated material as function of turns. An increase in hardness is found from 600 HV up to 900 HV.

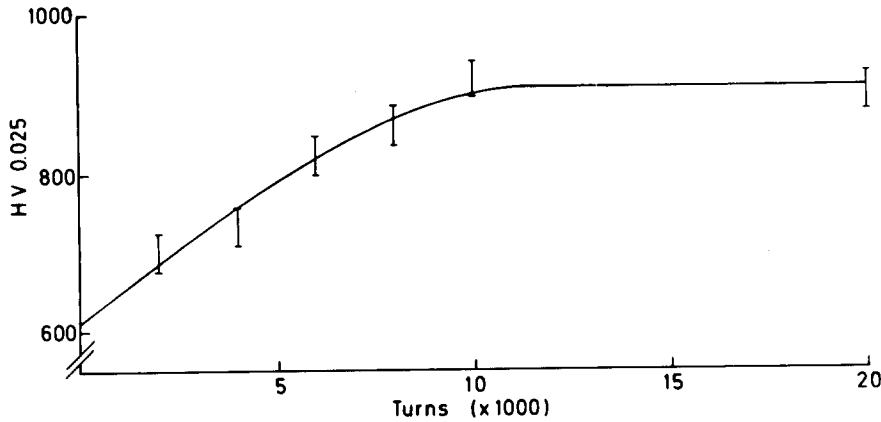
Fig. 3b Wear induced hardening.

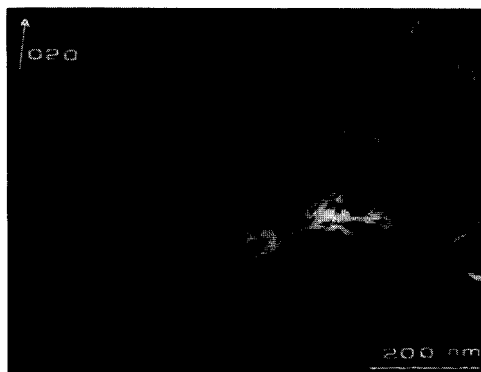
Fig. 6 (Right) Pile-up of dislocations near a cell boundary.

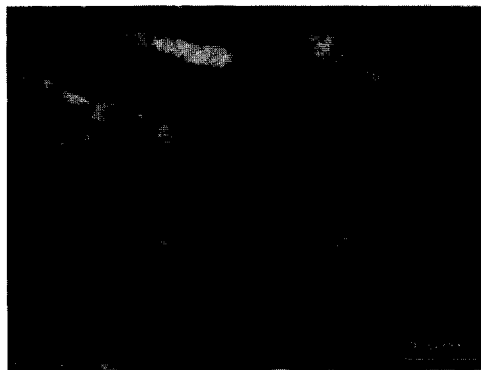
Fig. 8 (Right) Cracked martensite (see arrow) near a worn surface.

Laser melting of X210CrW12 chromium steel results in austenite with segregated M_3C carbides. During wear the material transforms into α -martensite. The hardness of the laser processed material increases from 550 HV to 900 HV in the worn material. Cracks are present in the brittle martensite. Supersaturation of alloying elements increases the stacking fault energy of the laser melted austenite. The absence of stacking faults prevents the formation of hcp-martensite. The laser melted material is more ductile than conventionally hardened material. The abrasive wear resistance did not differ significantly.
